## **SECTION 2. PROBLEMS AND OPPORTUNITIES**

### **2.1 EXISTING CONDITIONS**

**CURRENT CONDITIONS AT  
MILL RIVER PARK  
STAMFORD, CONNECTICUT**

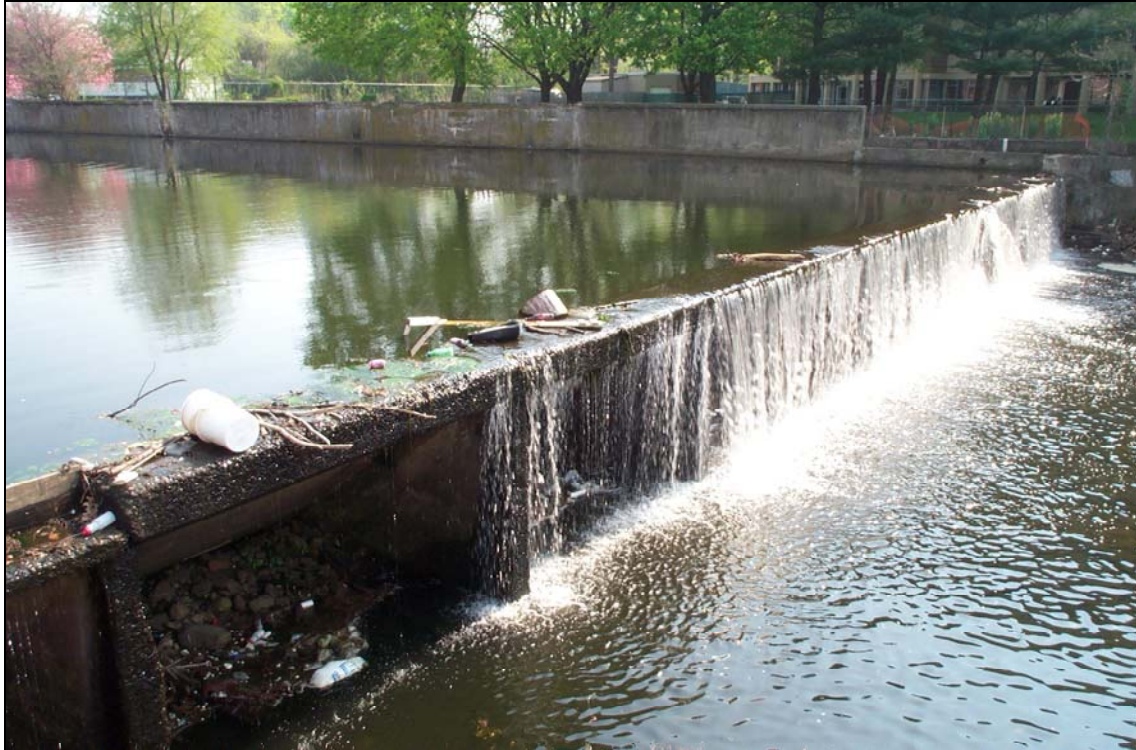
Restoration efforts are focused on rehabilitation of Mill Pond located behind the Main Street Dam (Plate 2). The concrete dam is 9.3 feet high and the impoundment behind it is defined by 15-foot high concrete floodwalls (Figure 4). The pond extends from the dam upstream to the Broad Street Bridge.

Water movement through the pond is slow, allowing sediments to fall out of suspension, creating a bed of sediments, which would require dredging every few years to maintain a pool in the impoundment. The bed is primarily unconsolidated, filled with trash, choked by aquatic plants, and is at times malodorous. Resident Canada geese flock in large numbers to the pond and adjacent park, compounding pollution issues. The pond bisects Mill River Park and separates downtown Stamford from residential neighborhoods. Mill River Park consists of a lawn with mature urban trees located directly adjacent to the pond's retaining walls.

**Plate 2. Main Street Dam**

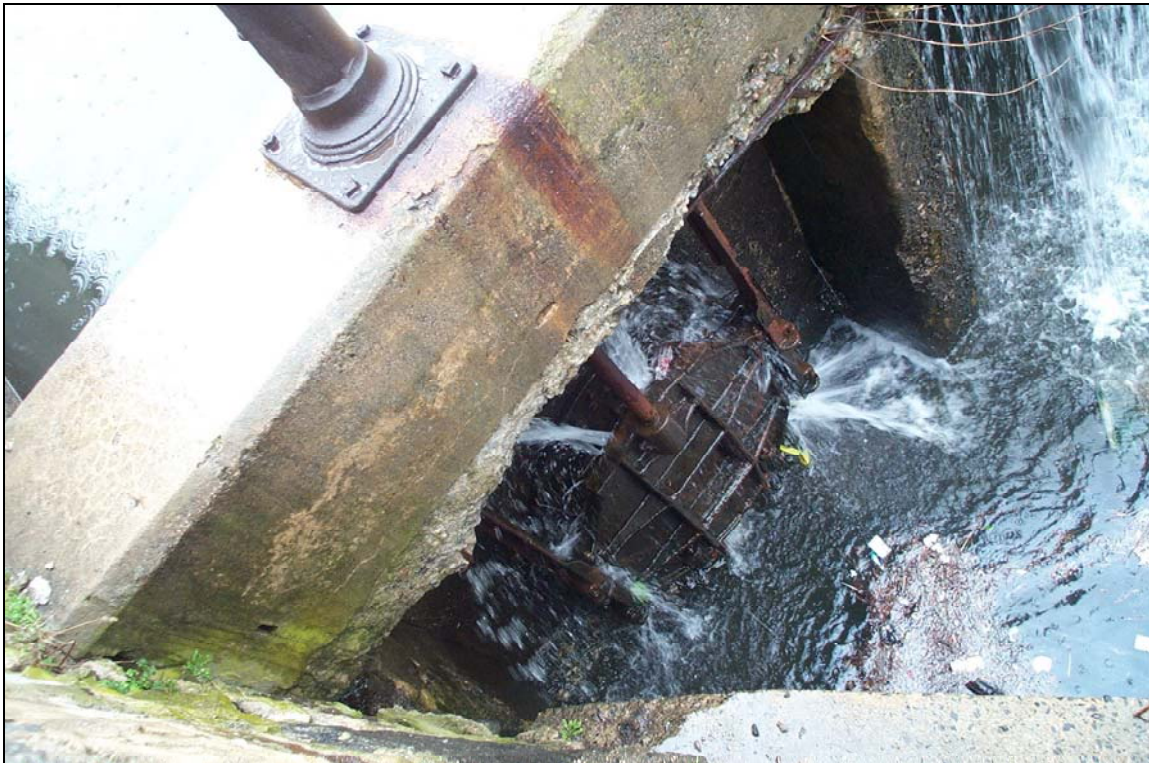
The Main Street Dam is currently in need of repairs (Plate 3) and any construction associated with the dam or pond would require extensive modifications to ensure the stability and function of the dam. As mentioned in Section 1, conceptual plans were developed for an Alaskan steep pass fish ladder for Main Street Dam to partially restore fish passage. Those plans include a requirement for the city of Stamford to perform repairs to the dam structure prior to fish ladder installation. The fish ladder measure has been further investigated in this study and included in Alternative 4 of this study. Dam repair would continue to be required for this fish-ladder alternative. Reinforced concrete walls that confine the pond on all sides are also in need of repair (Plate 4).

**Plate 3. Failing sluice gate of the Main Street dam**

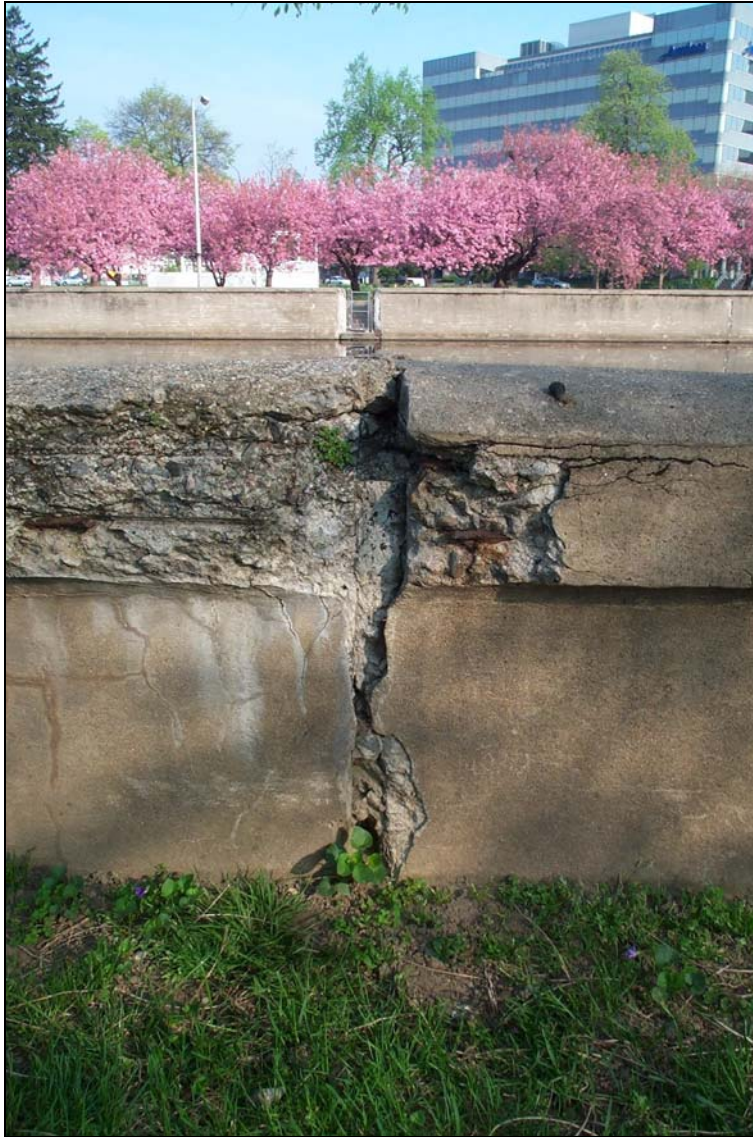
**Plate 4. Cracked retaining wall of the Mill Pond impoundment**

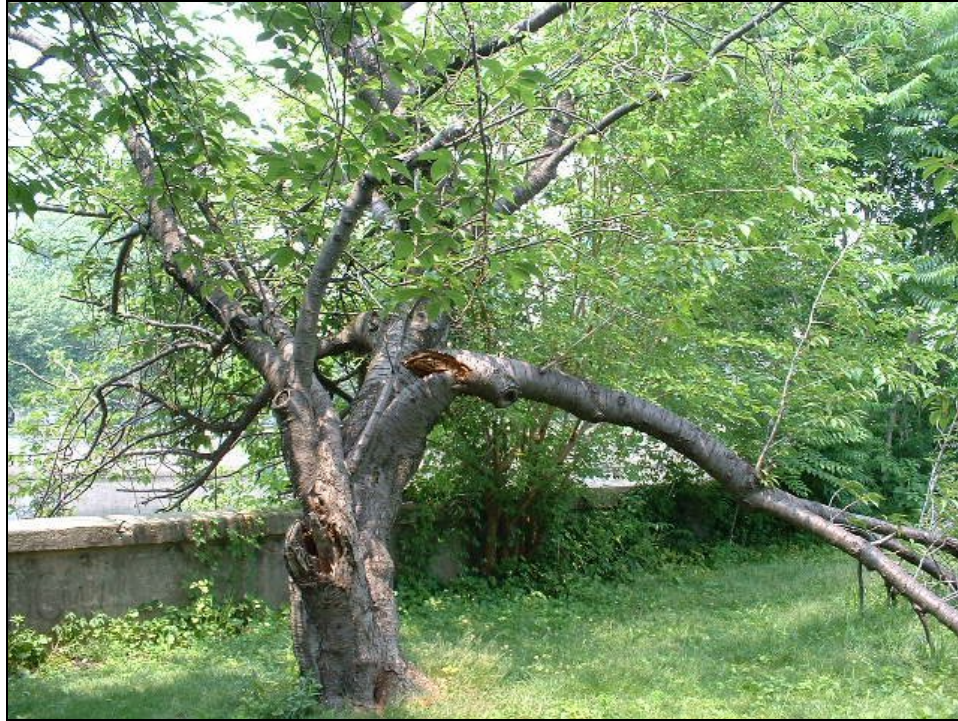
The cherry trees in Mill River Park are a concern for aesthetics as well as safety as boughs and whole trees begin to die from disease and old age (Plate 6). The cherry trees will require replacement if they are to be retained alongside the floodwalls. Terrestrial habitat is poor and will not maintain itself, requiring ongoing maintenance of exotic, ornamental, and lawn areas. The unsightly nature of the pond and the lack of connection to surrounding areas will discourage use by Stamford residents.

**Plate 6. Damaged cherry tree in Mill River Park**
